## 2012 Feature Accomplishments

### Terrell Creek Dam Project-

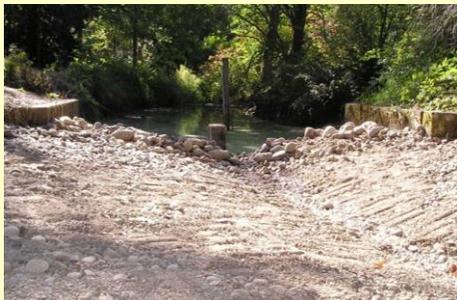
Lake Terrell Dam was replaced with a reinforced concrete weir placed into the existing spillway structure. The stream channel was elevated to the weir level. Migrating salmon can now access the lake and upstream habitat. (post-construction)

**Project Summary and Results** – After garnering feedback and approval from stakeholders, the Whatcom Conservation District received funding to resolve impacts on Terrell Creek. The Lake Terrell Dam was replaced with a reinforced concrete weir placed into the existing spillway structure. The top of the weir consists of shallow sloping shoulders that drop to a central low-flow triangular weir. The elevation of the central low-flow weir crest is lower than the original dam resulting in a minimum dry season flow of 1.1 cubic feet per second. The weir design will “meter” out water slowly through the dry summer months ensuring that 27,350 linear feet of Terrell Creek below the dam contains minimum flows needed to support juvenile salmon.

Following installation of the weir, the stream channel below was elevated to the weir level by adding 2,500 tons of compacted fill and 500 tons of spawning gravels. Pools or riffles were created and large woody debris was placed in the channel. Migrating salmon can now swim over the dam without any impairment and have access to 17,750 linear feet of upstream habitat including 7,400 linear feet of stream with quality spawning gravels and good riparian cover. Upstream riparian areas were also restored by planting 5.6 acres along 4,340 linear feet of stream bank with native tree and shrub buffers.

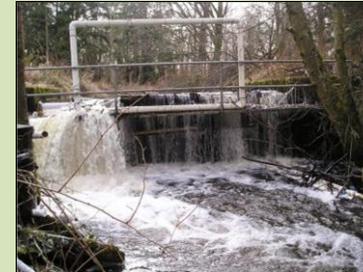
Lake Terrell Dam (before)

nourishing the upper watershed. However salmon in Terrell Creek have been adversely affected by a 7' high dam constructed in the 1950s that not only blocks fish passage but also impounds water from surrounding wetlands that would otherwise provide summer flow in the stream. Lake Terrell Dam was constructed to enlarge a vast wetland complex to increase sport fishing and waterfowl hunting. Despite the challenges, populations of Coho Salmon remain in the stream. Chum Salmon have been released for the last few years.
